Pedestrian and Bicycle Safety Evaluation for the City of Emeryville at Four Intersections

Pedestrian and Bicycle Safety Evaluation for the City of Emeryville at Four Intersections:

Powell and Frontage, Powell and Route I-80, Powell and Christie, and Christie and Shellmound

August 2005

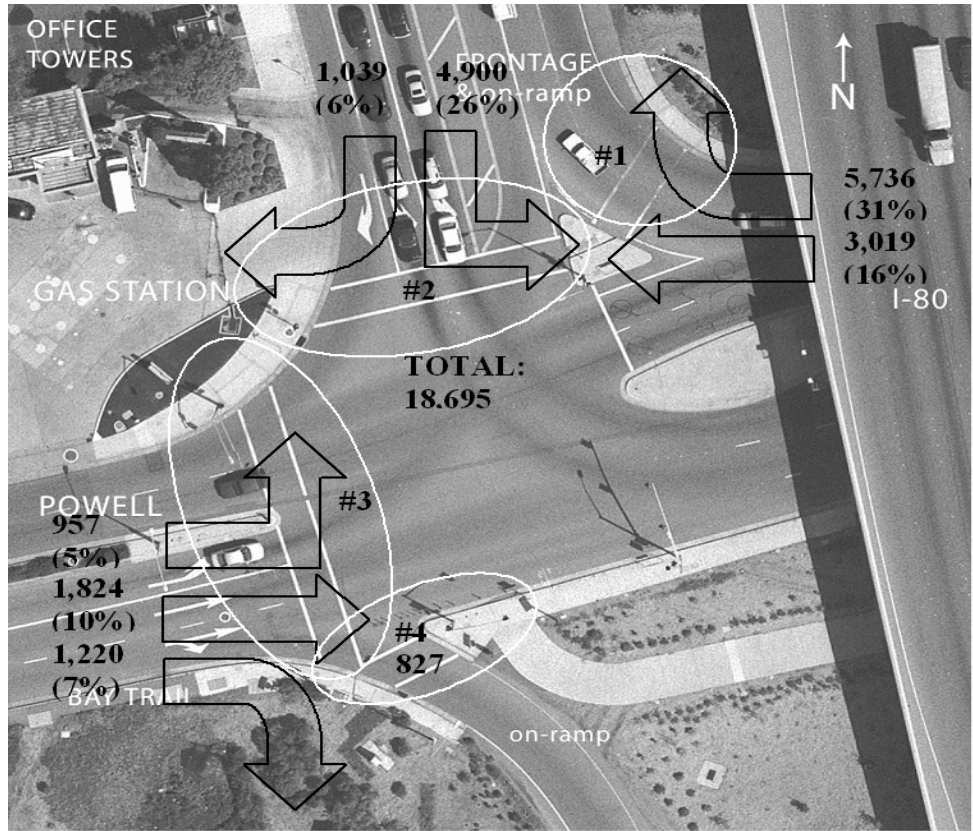
Figure 5: Aerial Photo of Powell and Frontage

The major issue at this intersection is violation of pedestrian right of way by right-turning vehicles that accelerate when approaching (#4) or entering (#1) freeway on-ramps. The vast majority (82%) of encroachment on pedestrian right of way occurred with right-turning vehicles. Visibility is a problem both for pedestrians and drivers. Drivers often are not looking for pedestrians when making these turns, and pedestrians have a difficult time seeing vehicles approaching from behind them (e.g., crossing west on #1 and crossing east on #4).

Pedestrian compliance with crossing signals is also an issue. Fully half of the observed pedestrians finished crossing with a “solid red hand” signal, the highest percentage of the four intersections. In part, this is because 36% of pedestrians began crossing either on the “flashing red hand” or the “Solid red hand” signals. Also, the long crossings (#2 and #3) are difficult to complete in time, and the lack of safe refuges increases pedestrian exposure to risk. The existing signal timing is inadequate, particularly at Crossing #3.

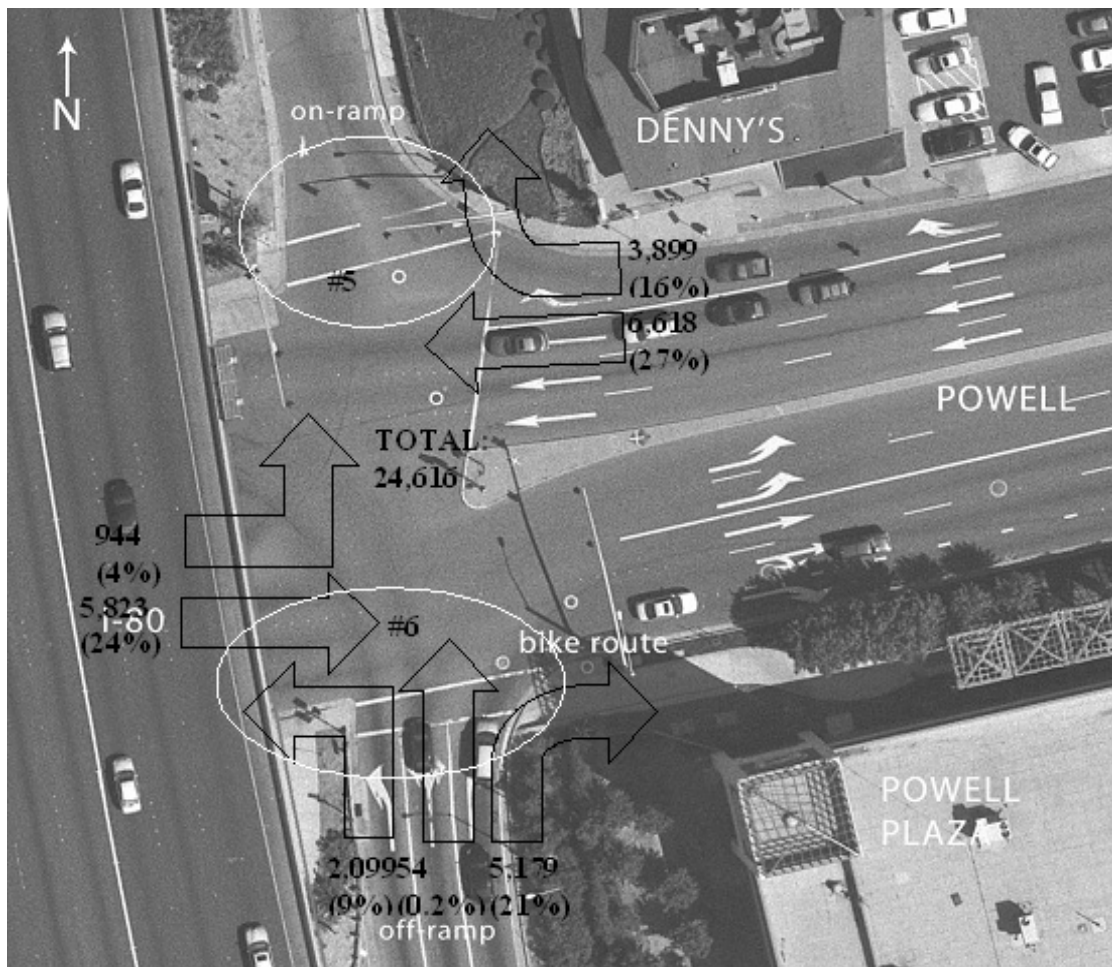
Figure 6: Aerial photo of Powell and I-80 on-ramps

During periods of high congestion, many drivers use this intersection to bypass traffic on I-80. This is facilitated by the “through” option in the center lane from the off-ramp which allows vehicles to simply exit, cross through the intersection, and then re-enter the freeway. The vehicle data provided by the City indicates a low number of northbound through vehicles (54) during the two observation periods combined. However, during periods of heavy freeway congestion, many vehicles per cycle using this intersection to bypass the freeway were observed.

Compared to the other intersections, pedestrians at Powell and I-80 were more likely to change stride to avoid a vehicle. The intersection also had the second highest number of vehicle violations of pedestrian right of way. All encroaching vehicles were turning right.

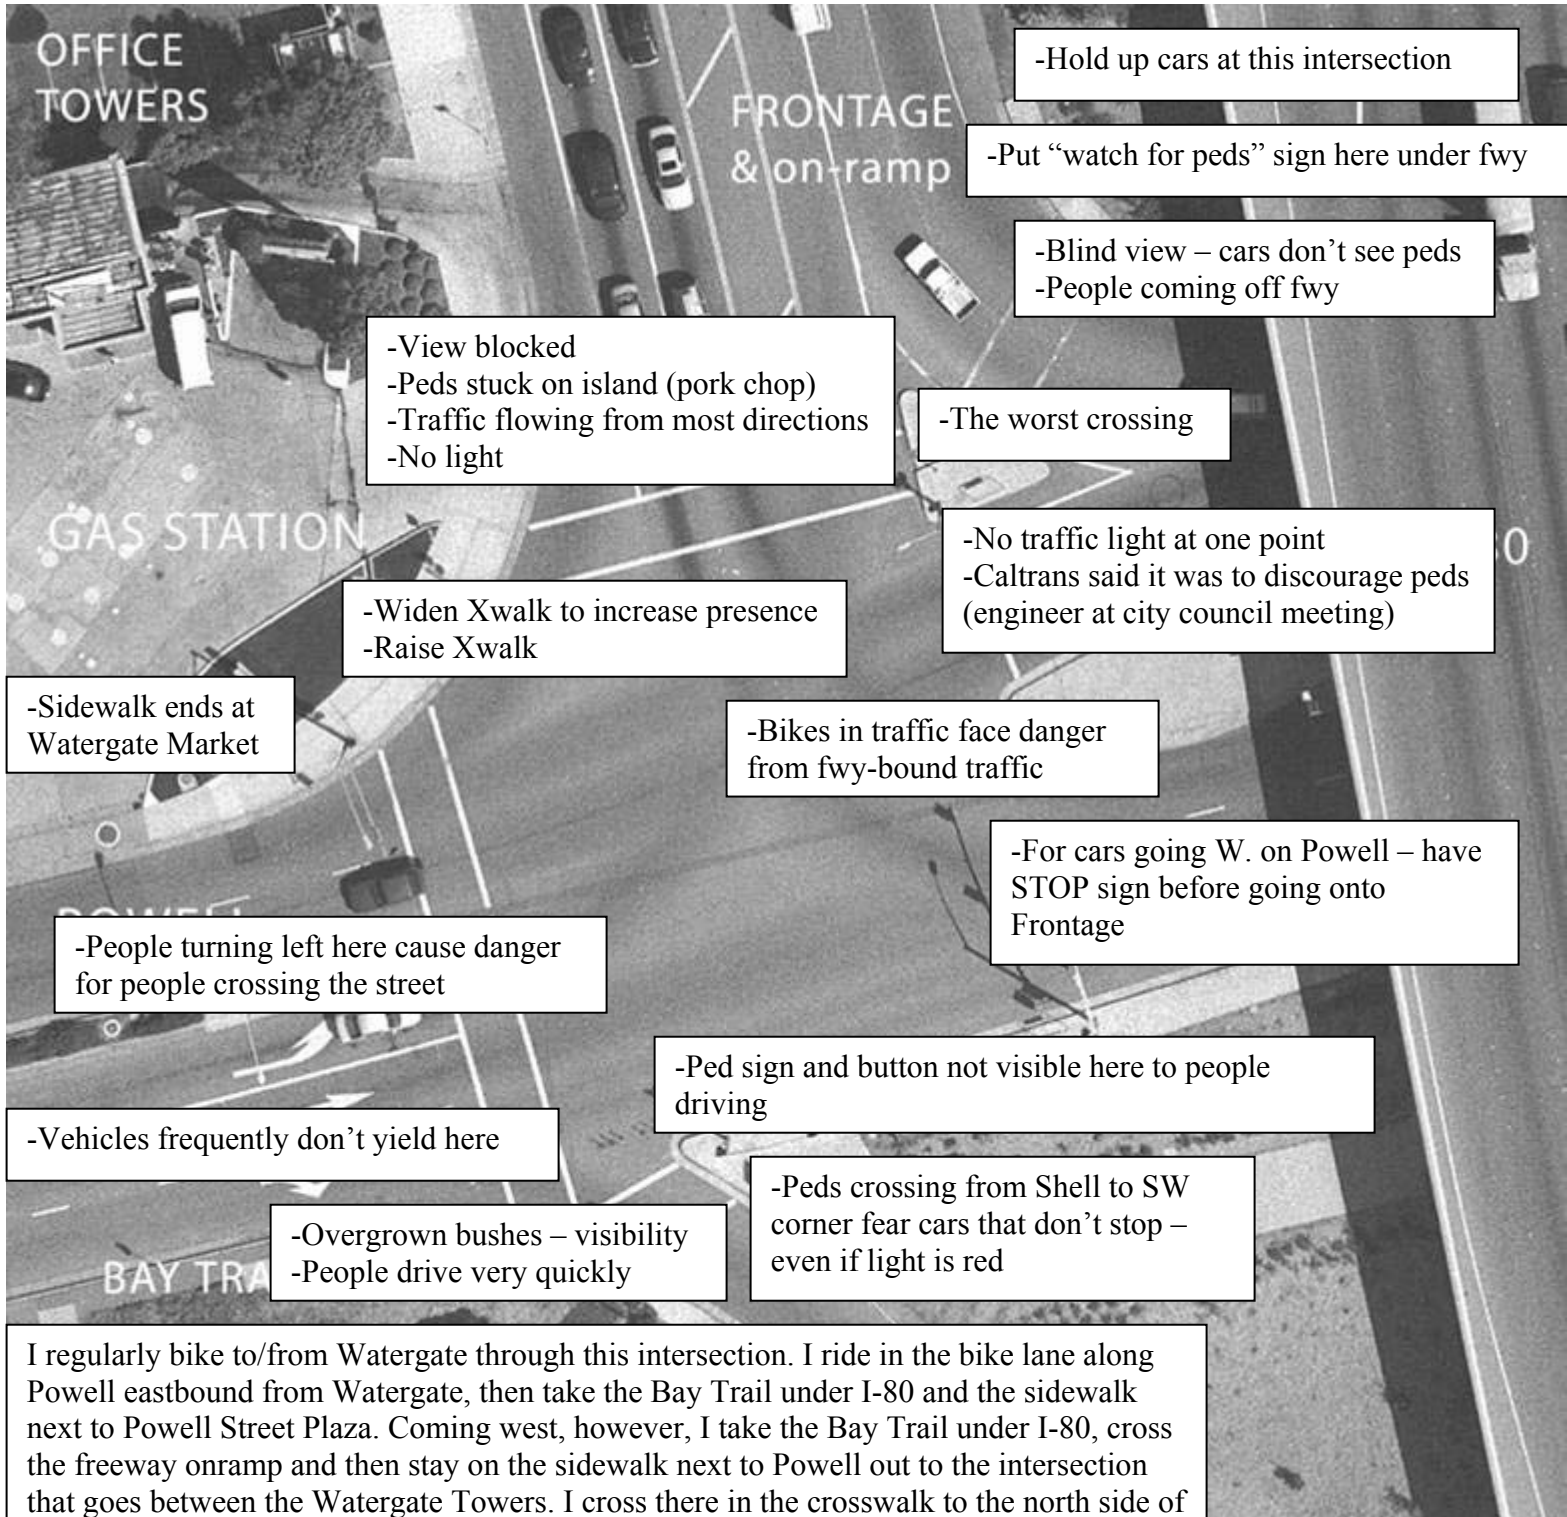
Powell and Frontage

-View blocked
-Peds stuck on island (pork chop)
-Traffic flowing from most directions
-No light

-Hold up cars at this intersection

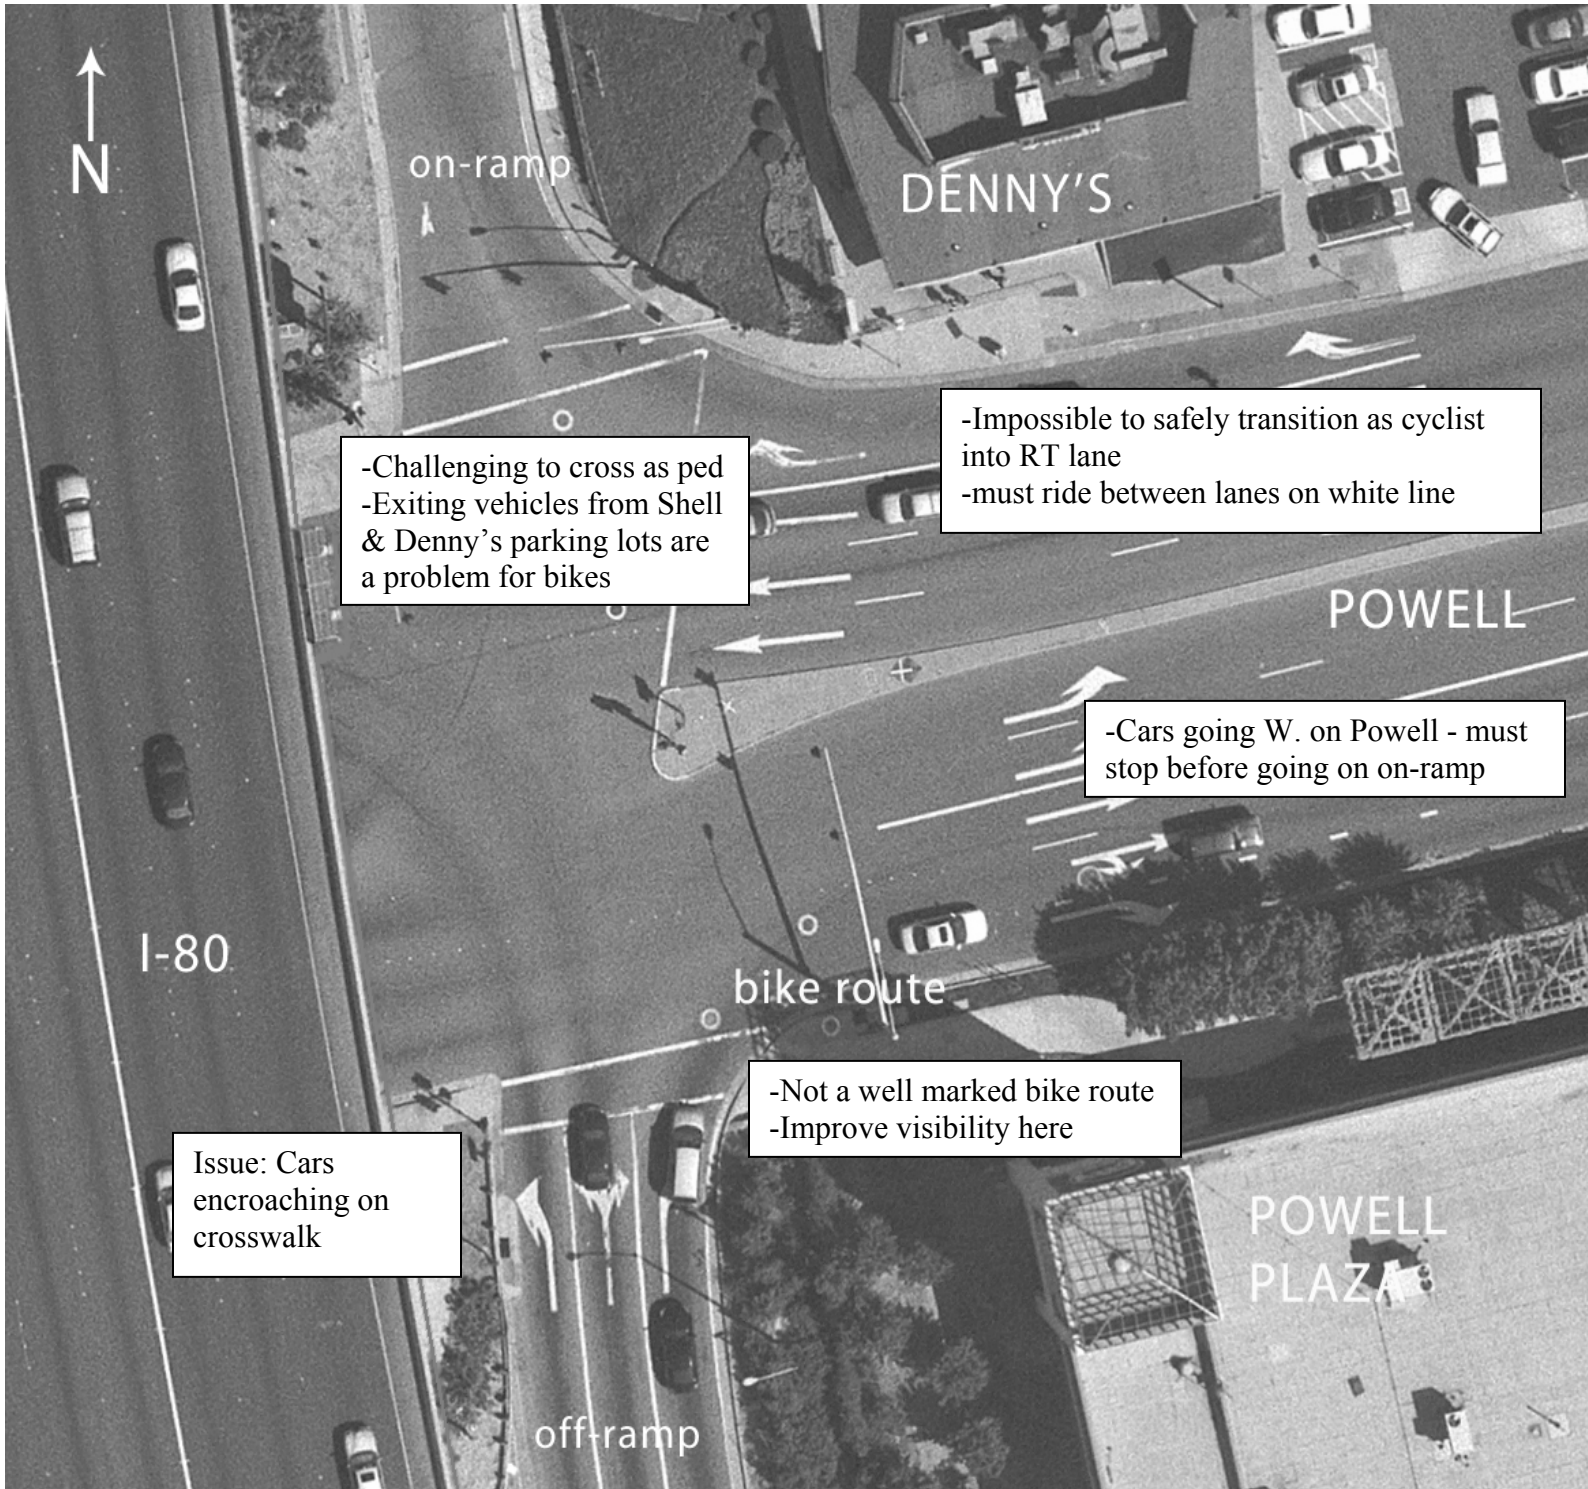
Powell and I-80

- Cars coming off freeway go fast, don't watch for peds, don't obey lights
- Visibility for peds/bikes
- On Northside, going west, ped sign useless
- Person crossing South intersection crosswalk have to go out into intersection to get by cars sitting in crosswalk
- Denny's to Watergate: Need to cross 2 lanes of traffic on bike to get across it
- Reach out to Arts Commission, PD + engineering, put banners up encouraging safety
- Planned art project for under freeway to improve safety lighting
- Lighted ped crosswalks
- 2 right turns = big problem

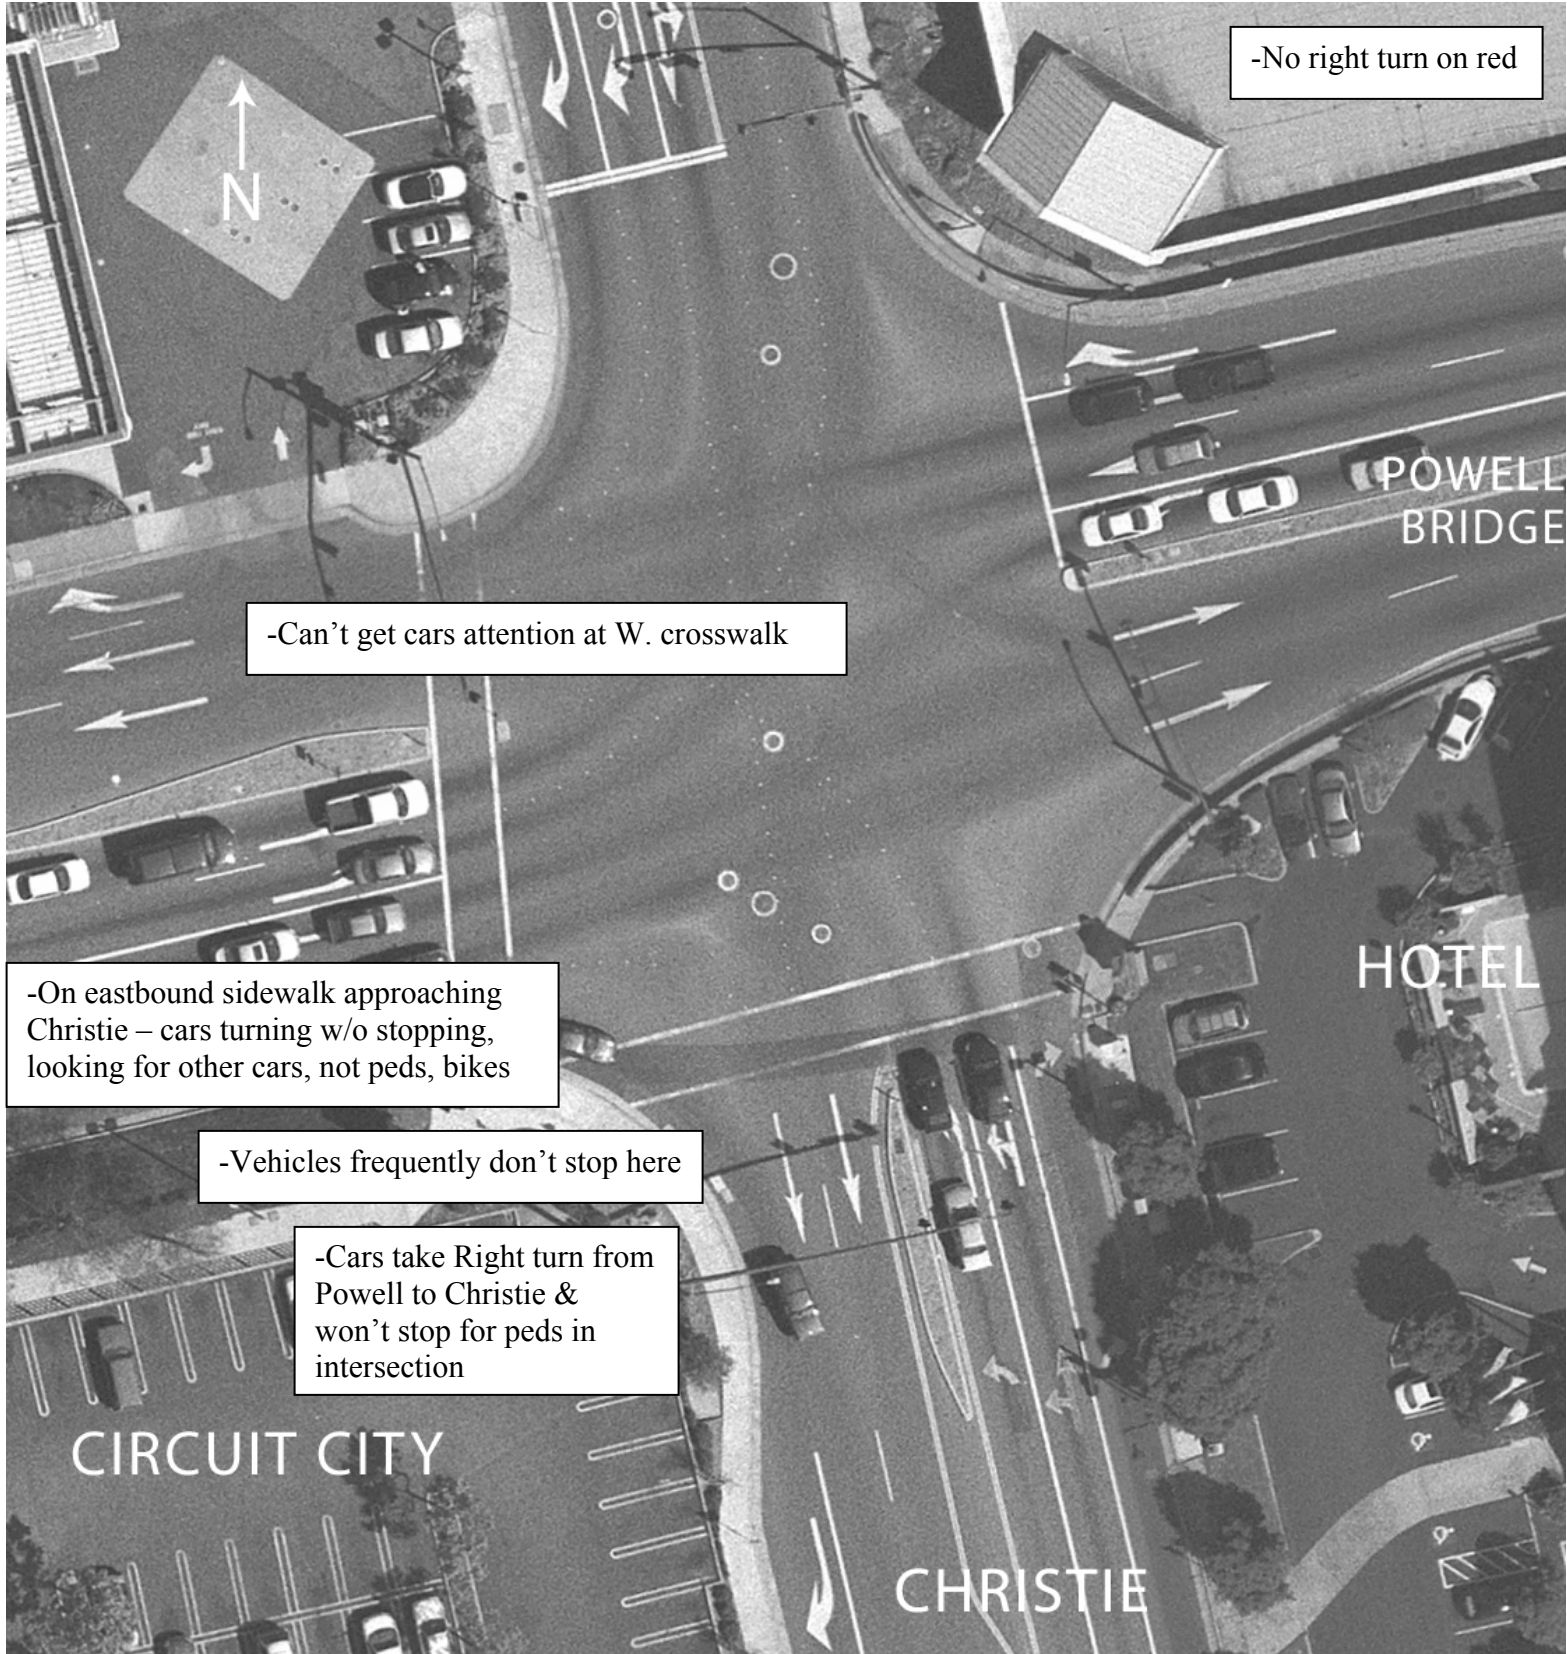
Powell and Christie

-No right turn on red

-Can't get cars attention at W. crosswalk

- Groups of cars turning Left onto Christie run red lights. Culture of RLV. Hopefully cameras will help.
- Aggressive Right turns so peds choose not to cross Powell
- No Right on red will back up traffic on S-bound Christie. Countdown signals have improved situation
- Police stings
- Square off corners. Too wide radius.
- Traffic laws for peds

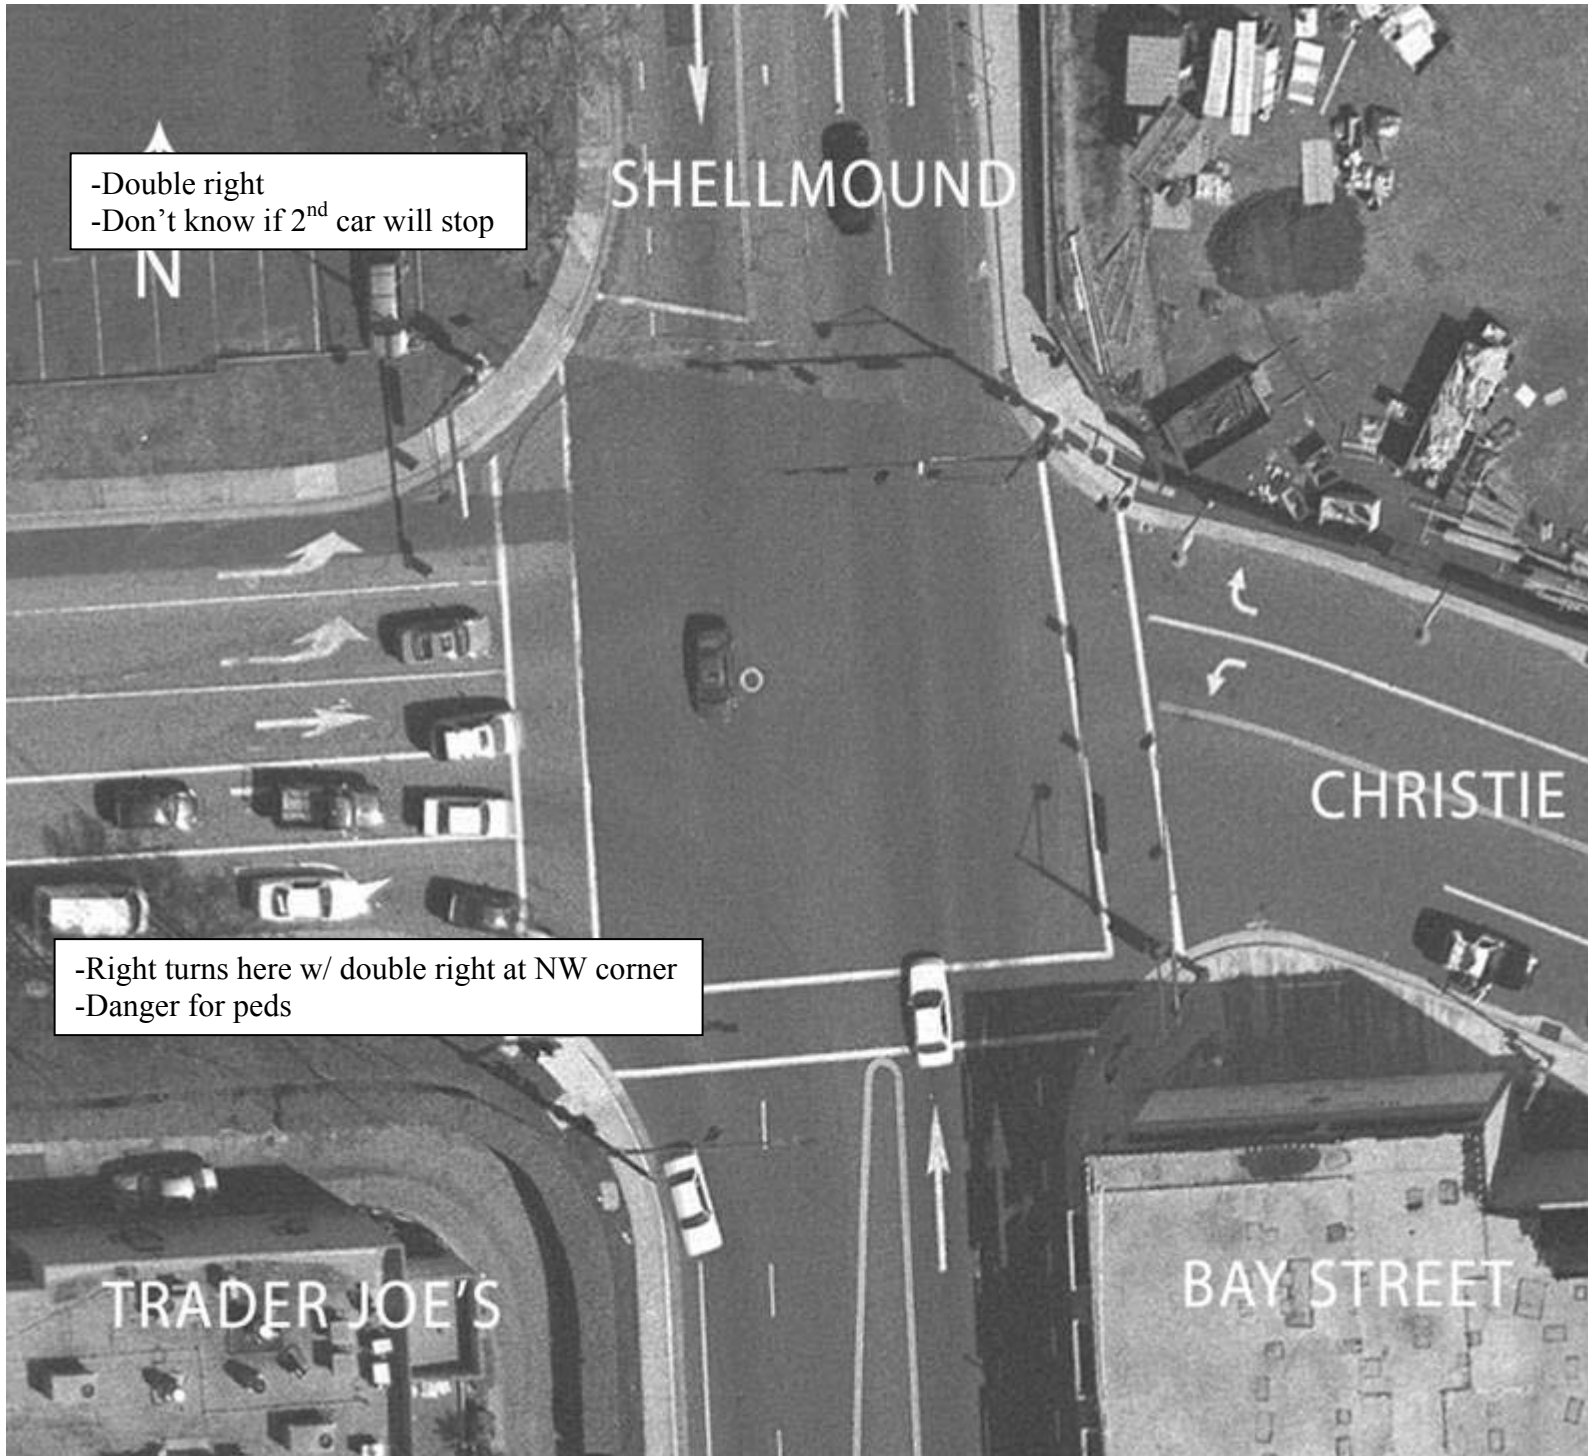
Shellmound and Christie

-Double right
-Don't know if 2nd car will stop

-Right turns here w/ double right at NW corner
-Danger for peds

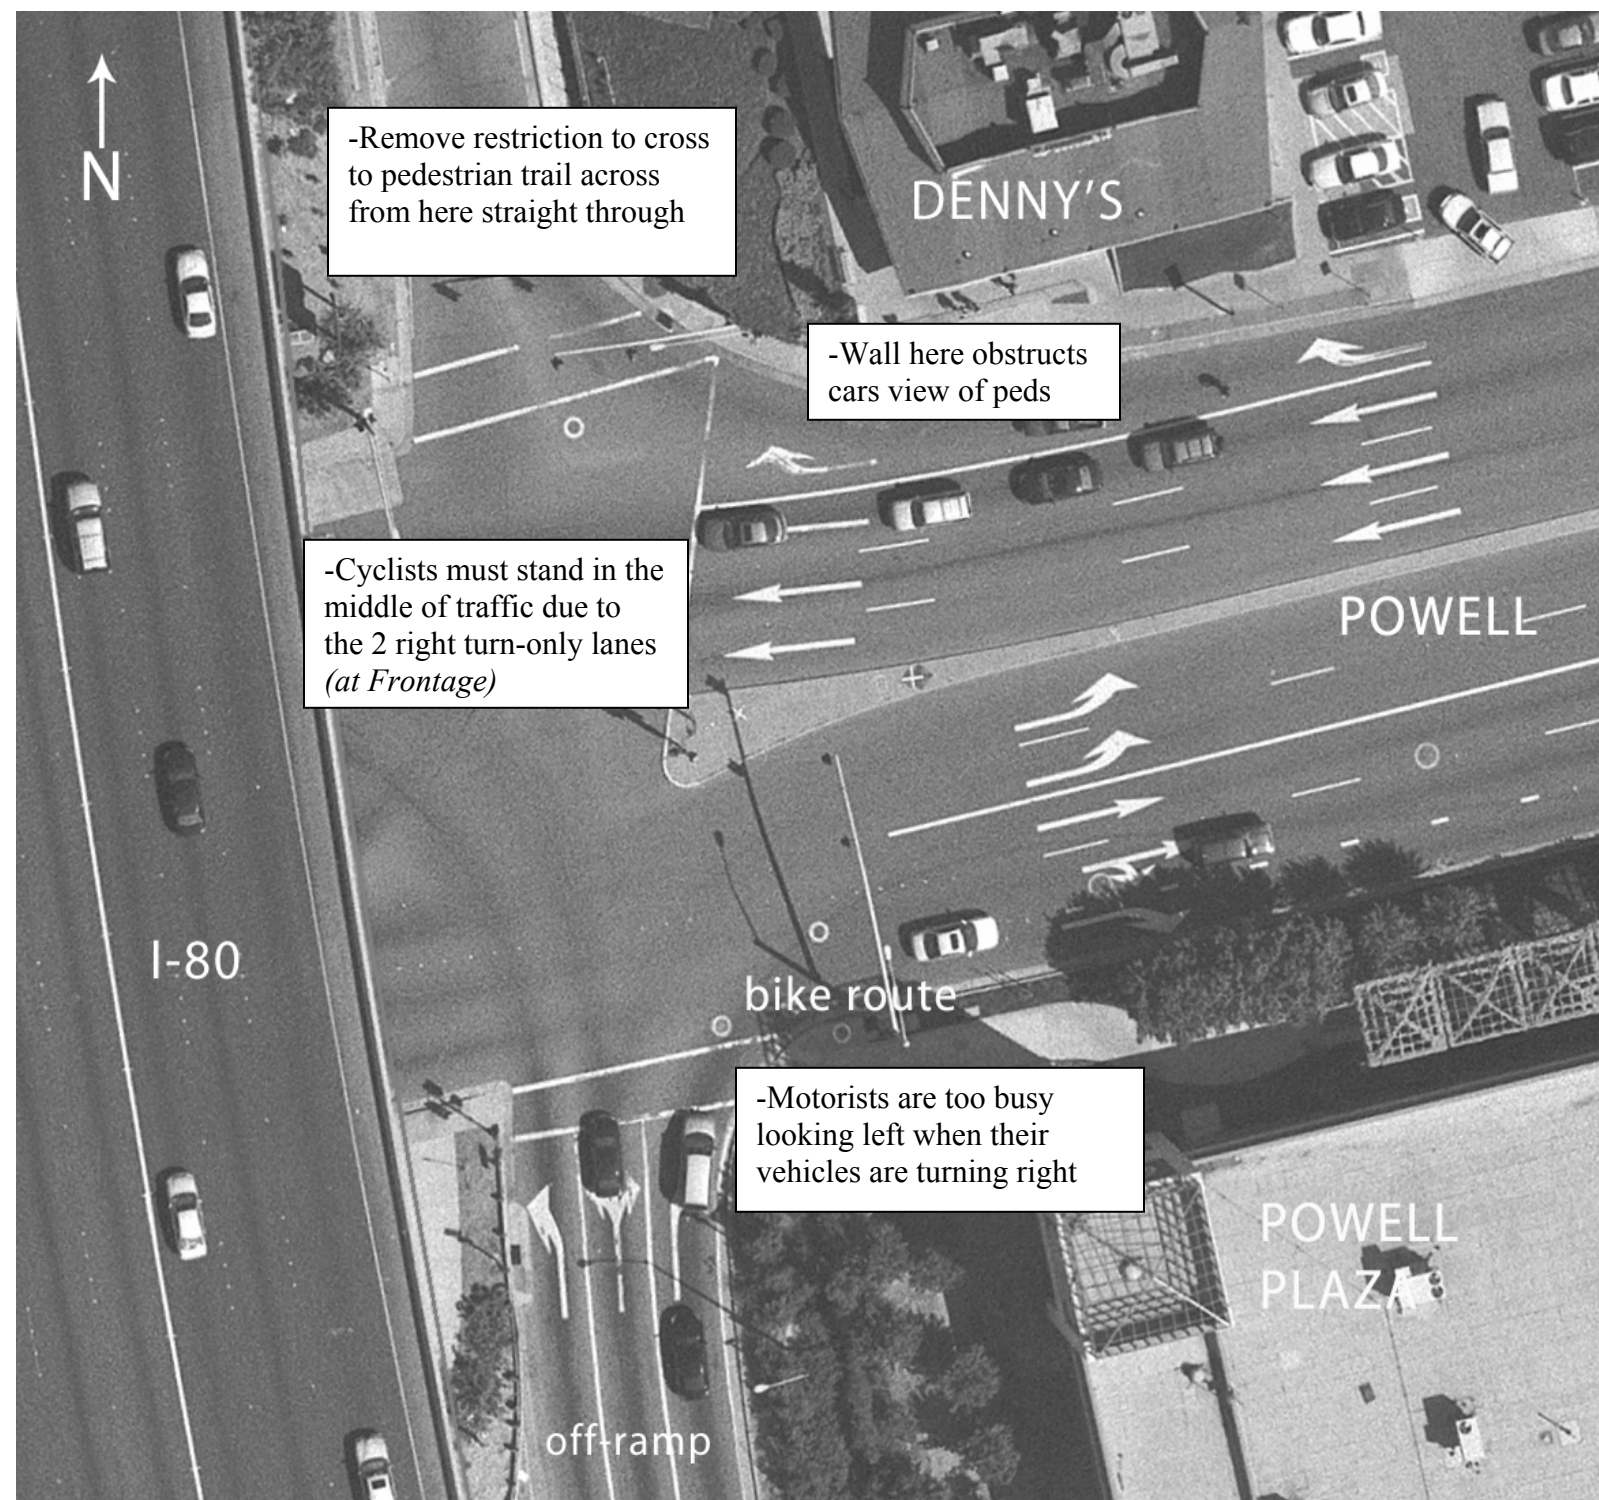
Powell and I-80

- Collision on bike at SE corner (designated bike route on south sidewalk)
- Cars exiting off-ramp don't stop before turning right
- Use tunnel/bridge instead
- Cars turning right from off-ramp aren't looking for peds/bikes
- Poor visibility on SE sidewalk because of embankment, foliage
- Denny's curb: poor visibility both for cars and peds because of ADA rail. Make curb sharper/square off.
- Bikes going west/through on Powell need to move to through lane: are placed in the middle of the road.

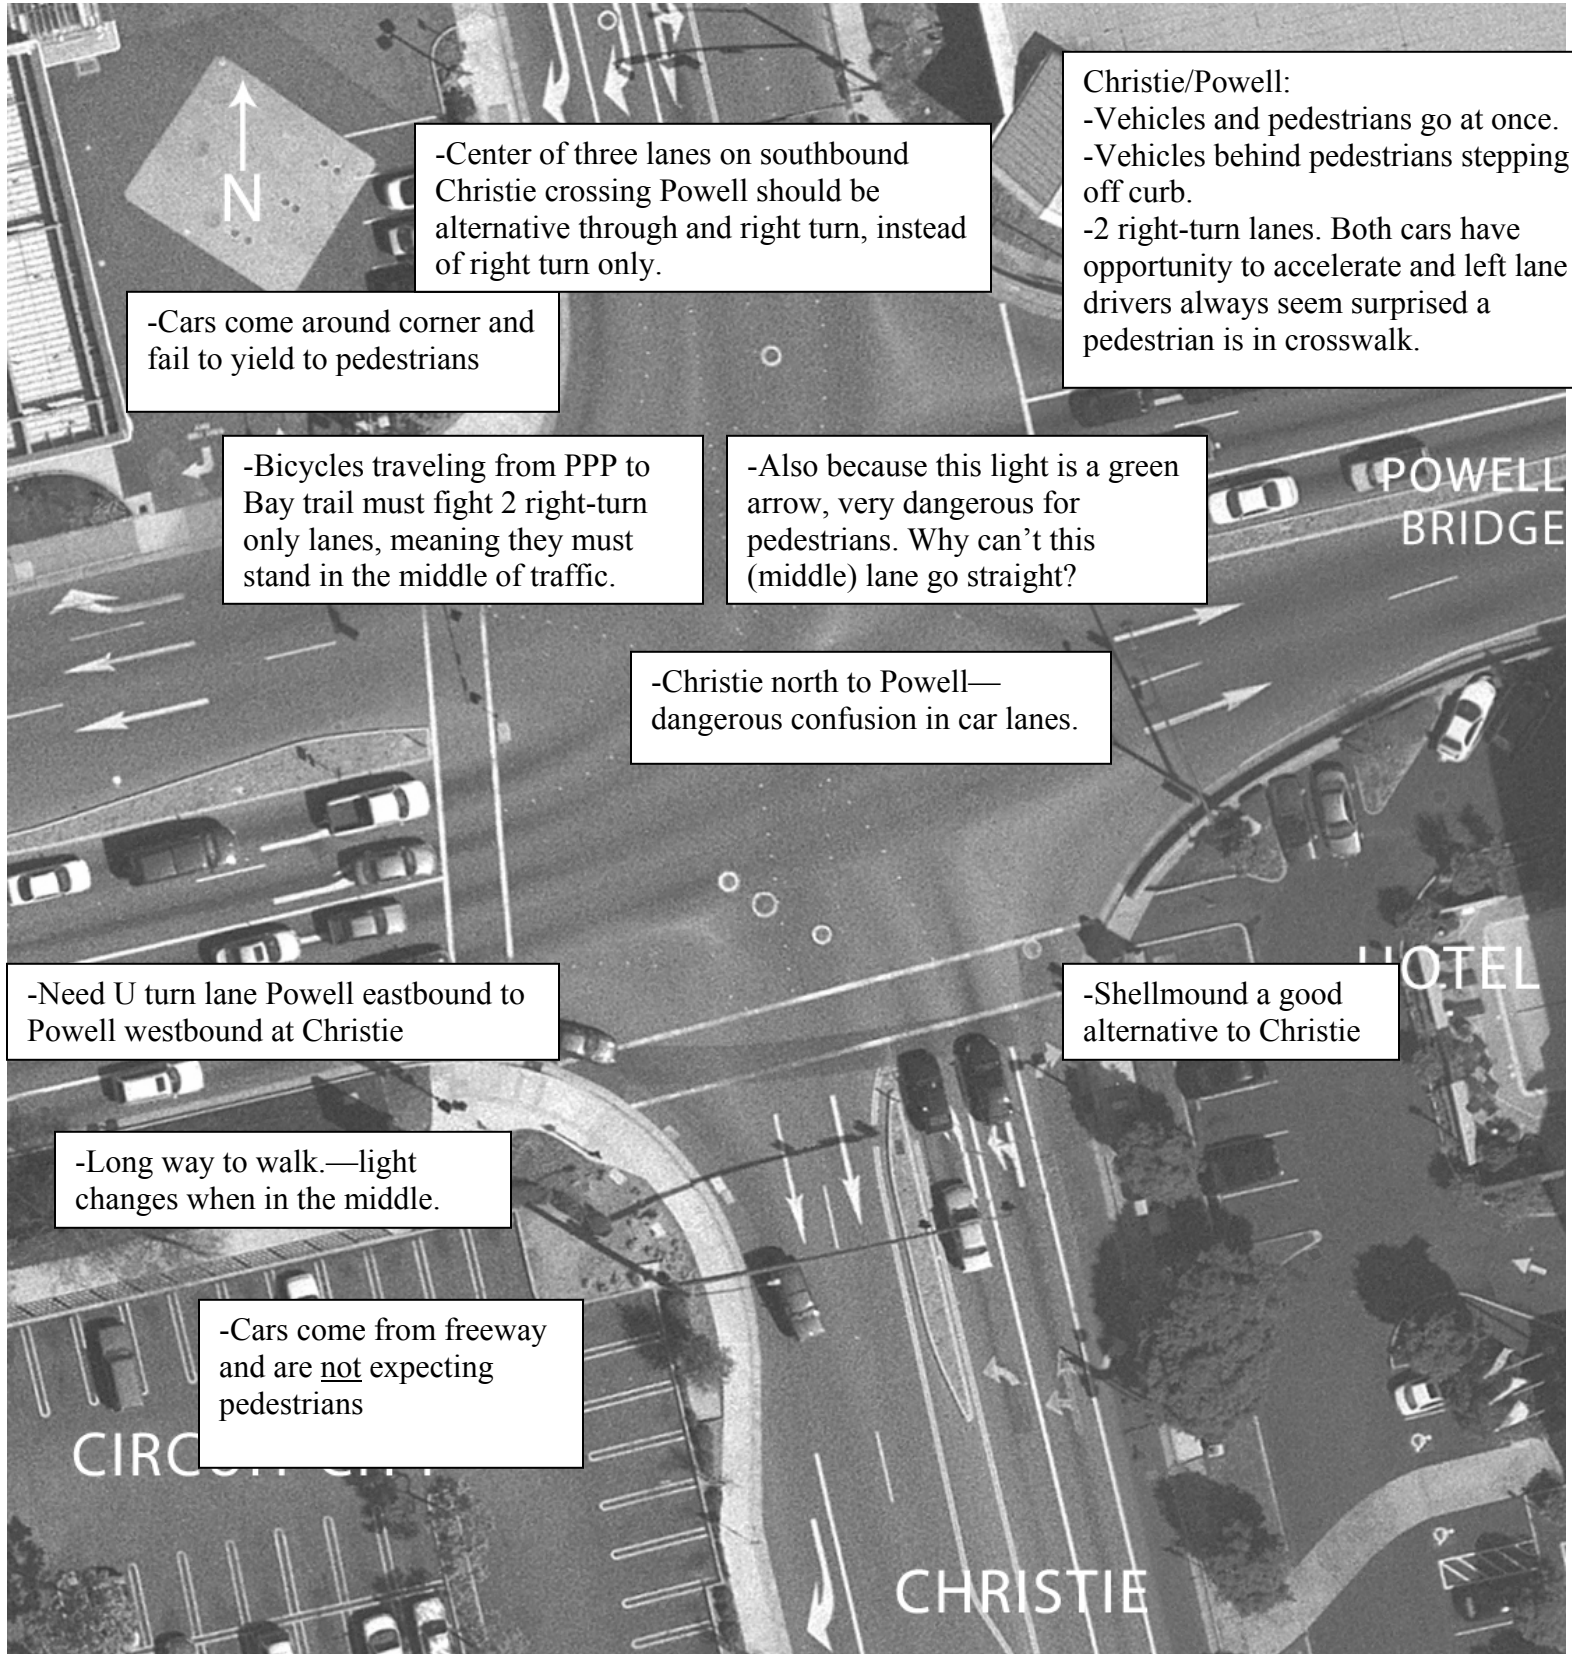
Powell and Christie

-Center of three lanes on southbound Christie crossing Powell should be alternative through and right turn, instead of right turn only.

Christie/Powell:
-Vehicles and pedestrians go at once.
-Vehicles behind pedestrians stepping off curb.
-2 right-turn lanes. Both cars have opportunity to accelerate and left lane drivers always seem surprised a pedestrian is in crosswalk.

- Right turn on red should be restricted:
 - EB Powell onto SB Christie
 - WB Powell onto NB on-ramp

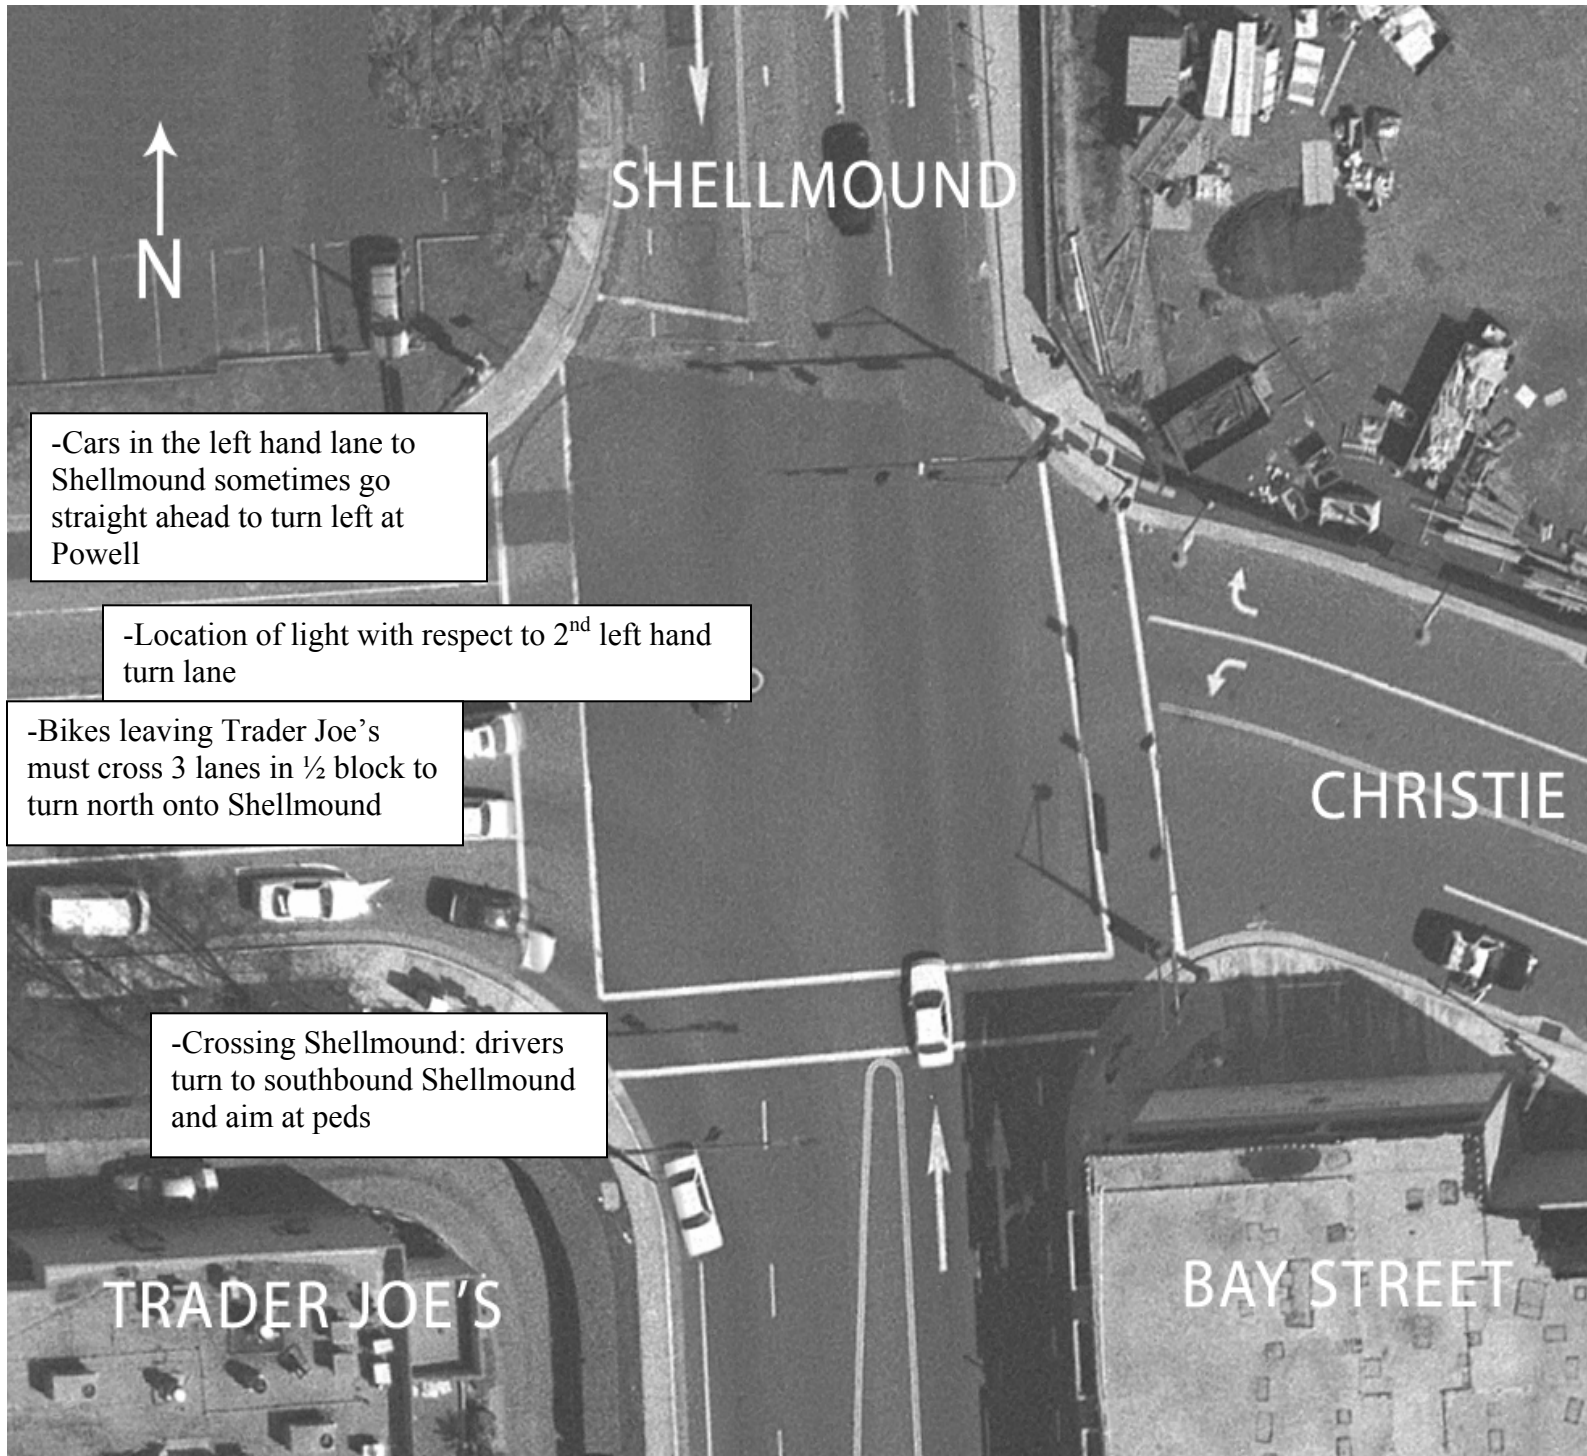
Shellmound and Christie

- Long crossings
- Right hand turns (WB Christie onto NB Shellmound) vehicles are going fast, don't see peds
- Can't get out to start crossing because of vehicles; then don't have enough time left to cross.
