# RECOMMENDATIONS TO IMPROVE PEDESTRIAN & BICYCLE SAFETY IN OAKLAND

July  
2017

By Wendy Ortiz, Miha Tomuta, Wendy Alfsen, California Walks;  
Jill Cooper, Katherine Chen, UC Berkeley SafeTREC

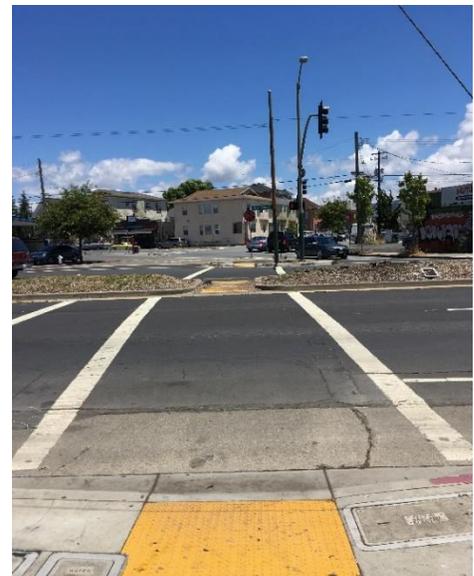
The posted speed limit along San Pablo Avenue in the workshop area—from 36<sup>th</sup> Street to West Grand Avenue—is 30 miles per hour (mph), yet drivers appear to travel at much higher speeds. Within the workshop area, it is a wide road with a center median, two travel lanes in each direction, parallel parking on both sides of the street, intermittent bicycle sharrows, sidewalks, and a mix of standard and high-visibility crosswalks. Research has demonstrated that wide streets and wide travel lanes are associated with higher vehicle speeds<sup>2</sup>, which affect the safety of people walking and bicycling. Additionally, over a dozen bicyclists were observed riding on the sidewalk due in part, perhaps, to excessive vehicle speeds long San Pablo Avenue.

*San Pablo Avenue in the Hoover-Foster neighborhood is a wide multi-lane road.*

Traffic calming measures, including a road diet, the addition of curb extensions, pedestrian safety islands, enhanced crossings, and on-street bicycle infrastructure, can decrease driver's speed along San Pablo Avenue. A San Pablo Avenue road diet can create space for separated bicycle lanes highlighted with green pavement to enhance visibility. We recommend that the City of Oakland work with community-based organizations and residents to submit an application to the Caltrans Sustainable Transportation Planning Grant Program to develop a focused Complete Streets plan for San Pablo Avenue with a shared vision for the corridor and identified priority projects to improve walking and biking conditions in West Oakland. We recommend that participants review the City of El Cerrito San Pablo Avenue Specific Plan and Complete Streets Plan to inform how they could structure a similar planning process for San Pablo Avenue in West Oakland.

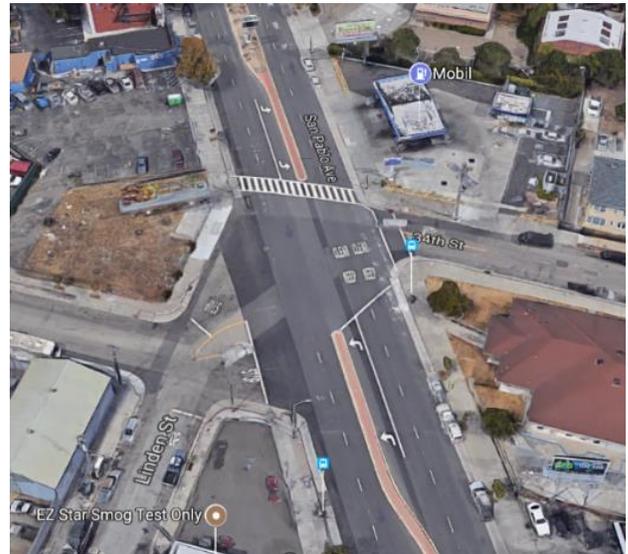
A variety of complex intersections can be found along San Pablo Avenue. These skewed intersections, where streets do not intersect at the traditional 90-degree angle, can be found along the corridor at 34<sup>th</sup> Street/Linden Street, Brockhurst Street/Filbert Street, and 31<sup>st</sup> Street. Such skewed intersections result in longer pedestrian crossings, difficult turning movements for drivers, and unsafe road user behavior due to the difficulty of navigating the intersection.

*A complex intersection at San Pablo Avenue and 34th Street. Source: Google*

A number of complex intersection redesign options can be found in the National Association of City Transportation Officials Urban Street Design Guide (NACTO). As the Guide shows, space from angled intersection redesigns can be used to create needed community gathering spaces such as parks and plazas or provide enhanced crossing zones. Latham Square in downtown Oakland is a recent example<sup>8</sup>. Moreover, Caltrans has long supported redesigning intersections and interchanges for its State Highway facilities, including authoring the 2010 publication “Complete Intersections: A Guide to Restructuring Intersections and Interchanges for Bicyclists and Pedestrians.” This document outlines 12 Guiding Principles for Caltrans engineers to evaluate pedestrian and bicyclist safety conditions at intersections and identifies common issues and treatments for various intersection types.

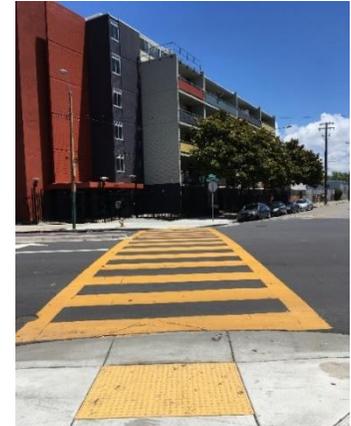
During the site visit, Cal Walks staff observed a number of crossing types along San Pablo Avenue including linear and skewed crossings. A high-visibility crosswalk is located on one side of San Pablo Avenue at Brockhurst Street. Signalized San Pablo Avenue crossings can be found at West Grand Avenue, 25<sup>th</sup> Street, 27<sup>th</sup> Street, 31<sup>st</sup> Street and Market Street. The majority of crossings are standard or continental crosswalks at unsignalized intersections. At most signalized intersections, only a single marked crossing across San Pablo Avenue exists, while the other is prohibited. This three-legged crossing design unnecessarily restricts

*High-visibility crosswalk at San Pablo and Brockhurst Street.*

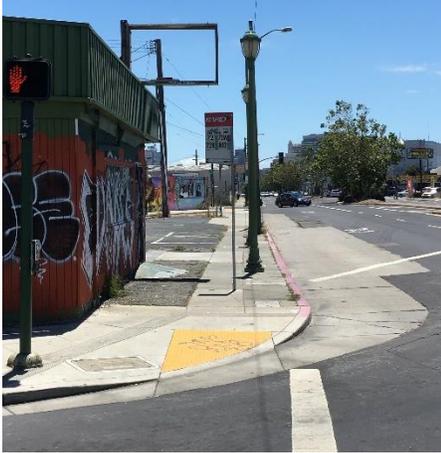
*One of only a few pedestrian-oriented light fixtures along San Pablo Avenue.*

A lack of pedestrian-scale lighting was observed during the site visit. A lack of adequate lighting was observed at transit stops, near storefronts, community activity areas, and I-580 underpasses, especially at San Pablo Avenue and West Street. Community murals located at I-580 underpasses would also benefit from additional lighting.

As part of its complete streets upgrades, Caltrans can install pedestrian-scale lighting on the underpasses and ramp feeder streets (35th and 36<sup>th</sup> Streets). A night-time light assessment is recommended to identify other specific areas needing additional lighting and repair/replace existing

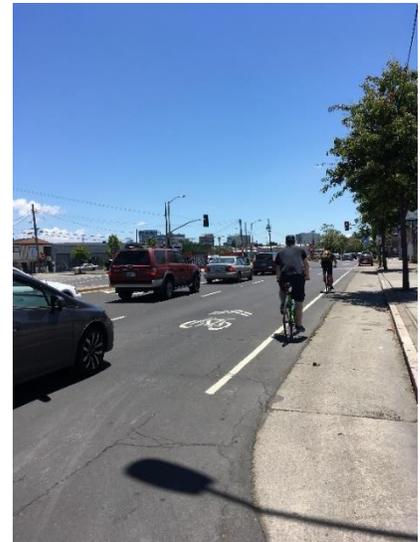
signs along San Pablo Avenue, identifying the street as a bicycle route and directing cyclists to Downtown Oakland or Lakeside Park. Residents noted that a main safety issue for cyclists along San Pablo Avenue appeared to be the high speed of drivers.

*Due to high speeds, bicyclists prefer the road shoulder to bicycle sharrows.*

Although sharrows are present along San Pablo Avenue, more and improved bicycling facilities and wayfinding is necessary to ensure safe travel and direct cyclists to existing and preferred bike routes.

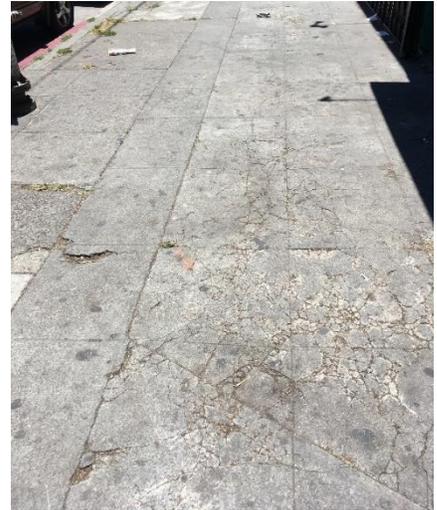
Sidewalks throughout the neighborhood are in disrepair, damaged by cracks or uprooted trees. Utility boxes in the middle of the sidewalk are in disrepair, including one at SPARC-It-Place with a hole larger than an adult foot. Sidewalks were also narrowed by various types of

debris from personal belongings, business signs and displays, trash, and overgrown vegetation as well as utility poles and pole anchors. Utility poles and pole anchors, which are light in color and missing reflectors can be obstructive and dangerous, especially at night. Low hanging tree branches blocked the view of the street as well as the view of drivers backing out of driveways.

*Cracked sidewalks and debris along San Pablo Avenue.*

There is a general need to ensure that sidewalks are level and free from obstructions, such as overgrown vegetation and uplifted sidewalks. Curbs throughout the San Pablo Avenue corridor need new paint, particularly red paint to daylight crosswalks at corners. Curb ramps should be updated to meet ADA requirements. Installation of a pedestrian safety island at San Pablo Avenue/Brockhurst Street is a priority due to the students and seniors who frequently try to cross this intersection to access transit and daily destinations. To increase visibility and safety, participants called for more investments in pedestrian-scale lighting, especially at transit stops, storefronts, and activity areas, while existing lighting should be surveyed to ensure it is in working order. Underpasses used as waiting areas for food giveaways would benefit from street furniture (benches, trash cans) and pedestrian-scale lighting (e.g., San Pablo Avenue from 35th-36th Streets).

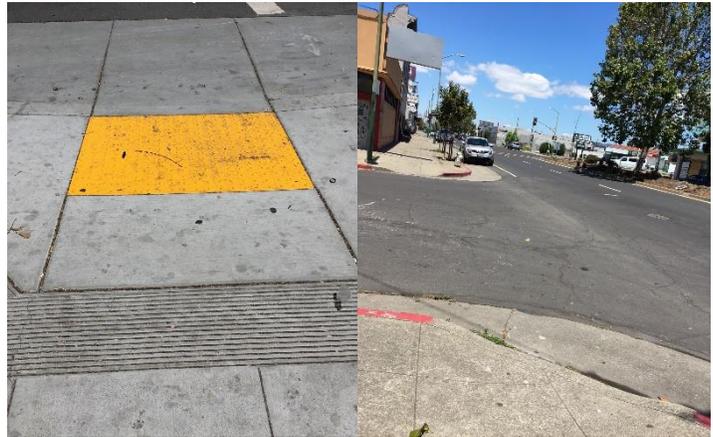
Curbs ramp designs and conditions varied along San Pablo Ave, from older concrete non-compliant

ramps, to newer ADA-compliant yellow truncated dome ramps, and to no ramps at some corners. In some areas, apex curb ramps direct pedestrians diagonally into intersections rather than directly into the crosswalk.

*Left: Newer ADA-compliant yellow truncated dome ramp.  
Right: Older, concrete non-compliant ramp.*

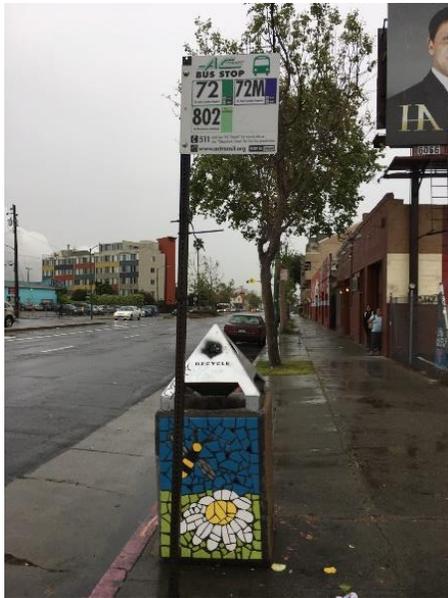
Lack of bus shelters and benches were noted throughout San Pablo Avenue. Residents were observed bringing their own chairs to sit and view activity on San Pablo Avenue. Residents commented that the City of Oakland removed several bus shelters in the area due to “safety” concerns. A transit stop on San Pablo Avenue, between 29th and 30<sup>th</sup> Street did have a bus shelter, however, the bus shelter was obstructing the sidewalk.

*Lack of bus shelter, bench, and pedestrian-scale lighting at San Pablo Avenue bus stop.*

Residents noted that a lack of pedestrian scale-lighting in some areas may be supporting certain types of negative activity. Minimal or no lighting near unmarked and unsignalized crosswalks makes it difficult for drivers to see pedestrians. Participants commented that the lighting at the I-580 underpasses was inadequate, especially at San Pablo Avenue and West Grand Avenue, San Pablo Avenue and 36th Street, and West Street and 35th Street.

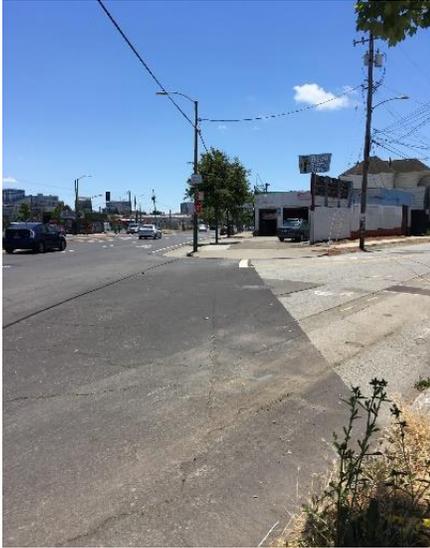
*Long, unmarked crosswalk at San Pablo Avenue and 31<sup>st</sup> Street.*

Pedestrian crossings are long, often requiring people to cross 9 lanes of traffic, including vehicle lanes, parking, and the median, with few or no pedestrian crossing enhancements. There is a lack of well-marked, enhanced crossings along San Pablo Avenue, particularly at 27th Street (signalized, no striping) and 34th Street (unmarked, unsignalized). At San Pablo Avenue and 24th Street, there are 5 crosswalks at this complex intersection but only 3 marked crosswalks. Participants noted that San Pablo Avenue lacked stop signs, traffic signals, high-visibility marked crosswalks, or other traffic control devices to assist residents in crossing the street. Participants were particularly concerned with the lack of traffic control markings and/or devices in proximity to schools, senior centers, and senior housing on the corner of San Pablo Avenue and Brockhurst Street.

Participants identified the need for high-visibility crosswalks and the addition of rectangular flashing or pedestrian hybrid beacons at numerous intersections along San Pablo Avenue, including at 32nd Street. To improve crossing conditions, participants also noted the need for more curb ramps and high-visibility restriping of faded crosswalks. Participants also expressed that some signalized intersections needed increased crossing times and pedestrian countdown signals. They requested that the City
