Blue Lake Rancheria Workshop Summary and Recommendations

Community Pedestrian & Bicycle Safety Training and Action Planning Creating Safer Streets for Walking and Biking

October 2019

Blue Lake Rancheria, California

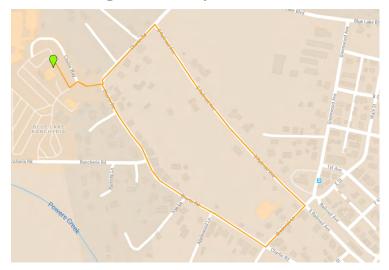
Route 1: Perigot Park & Gymkhana Field

The first route focused on streets leading to Perigot Park and Gymkhana Field, which are highly frequented by families on the Rancheria and in the City of Blue Lake.

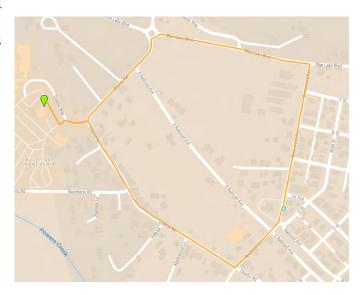
Route 2: Blue Lake Elementary School

The second route focused on the area around Blue Lake Elementary School and routes students and parents used to travel to and from school.

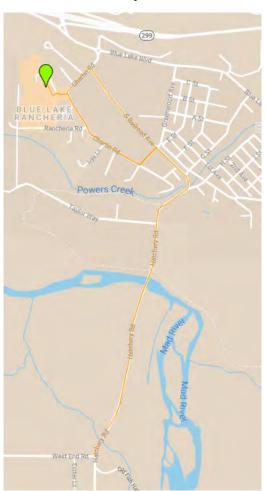
Route 3: Hatchery Road

This on-bike route focused on the main roads used to bike in and out of the Rancheria, with a focus on Hatchery Road, which families use to access Mad River.

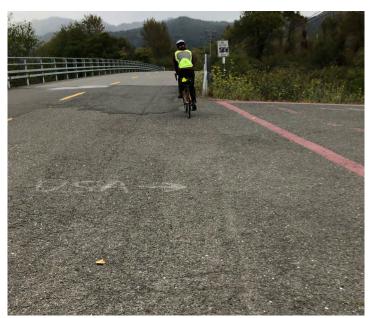
- Roadway conditions along Chartin Road, Railroad Avenue, and Hatchery Road were cracked, uneven, and difficult to maneuver for bicyclists. Drivers drive through the stop sign at the entrance to the Rancheria on their way to the casino and gas station.
- Participants on Route 1 noted that the pavement condition on Chartin Road was preferable for walking when compared to Railroad Avenue.

Cracked roadway on Hatchery Road.

The Project Team recommends Blue Lake Rancheria review the Hatchery Road Walkability Assessment and collaborate with the City of Blue Lake and Humboldt County to finalize plans to implement infrastructure improvements along Hatchery Road. In October 2017, Redwood Community Action Agency, City of Blue Lake and Humboldt County led a walking assessment with local residents to assess walking and biking conditions and provide recommendations for Hatchery Road. Incorporating all three jurisdictions that frequently use Hatchery Road will ensure that all community voices are being represented and that plans serve all road users.

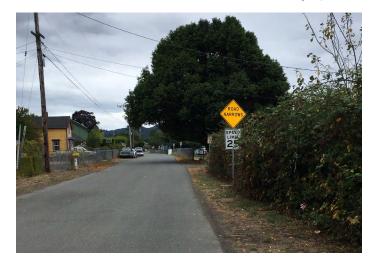
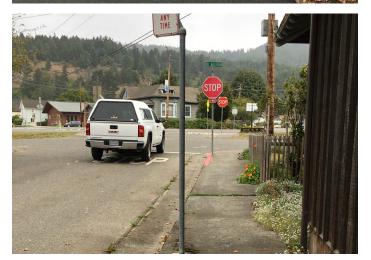
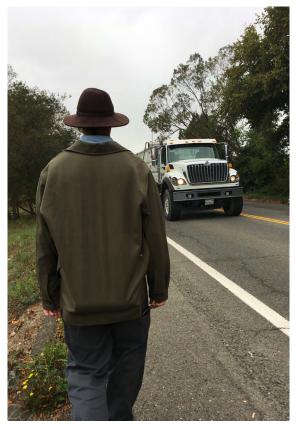
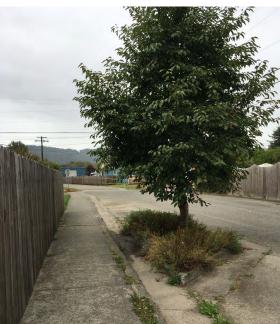
Sidewalk Conditions and Connectivity (continued)

- There are missing sidewalk segments along Chartin Road from Blue Lake Boulevard to the entrance of the Rancheria; along Hackett Road from the entrance to the Rancheria to Broderick Lane; along both sides of South Railroad Avenue; and along Blue Lake Boulevard from Greenwood Avenue to Chartin Road. These sidewalk gaps impact pedestrian connectivity between Blue Lake Rancheria and the City of Blue Lake and expose pedestrians, including students, to vehicle traffic.

- The sidewalks on Broderick Lane between Chartin Road and South Railroad Avenue are at street-level and lack curbs.
- During the workshop, Redwood Community Action Agency shared that the City of Blue Lake is currently in the process of designing and installing a walking path on Railroad Avenue. Participants agreed that a separated walking path would address many of their current safety concerns. Participants expressed an interest in working with the City of Blue Lake to integrate interpretive and celebratory features along the path that highlight the Rancheria community's history.

<u>Left:</u> Missing sidewalks along both sides of Hackett Road (top) and Chartin Road (middle) leading into the City of Blue Lake. Sidewalks along Broderick Lane (bottom) are level with the street.

<u>Right</u>: A participant walks on the shoulder of Blue Lake Boulevard as a truck drives by at a high speed (top). A tree along Broderick Lane (bottom) buffers the sidewalk from vehicles and provides shade for pedestrians.

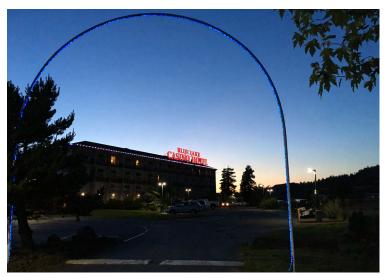
- There is a lack of street lighting in Blue Lake Rancheria and City of Blue Lake communities, including at key locations such as Perigot Park, Gymkhana Field, and bus stops in the City of Blue Lake.
- The majority of lighting in the Blue Lake Rancheria is limited to the Casino's parking lot lighting.
- In the City of Blue Lake, the majority of lighting is from flood lights attached to tall utility poles and from lights in residential yards. The flood light fixtures are located too high to illuminate pedestrian and bicycle paths, and the height and fixture design allow light to scatter, contributing to light pollution. Participants on Route 2 shared they would like more light in the community, but not at the expense of the dark sky.

<u>Left:</u> Lighting in the Blue Lake Rancheria parking lot is focused downward and unevenly distributed, which creates dark spots between cars and along pedestrian pathways.

<u>Top Right</u>: A flood light attached to a tall utility pole in the City of Blue Lake.

The Project Team **recommends Blue Lake Rancheria collaborate with the City of Blue Lake to perform a community-wide street lighting assessment.** This assessment would focus on street lighting and pedestrian-scale lighting needs, especially around community gathering areas such as Perigot Park, Gymkhana Field, bus stops, Blue Lake Elementary School, and the Rancheria, and pedestrian walking paths and crossings between the City and the Rancheria.

- The assessment would identify short-term lighting opportunities to increase street and parking lot lighting in the community, such as the installation of additional light fixtures on utility poles, replacement of light fixtures in need of repair, replacement of flood light fixtures to reduce light pollution, including glare.
- The assessment will also identify long-term lighting needs, such as the installation of pedestrian-scale lighting at key locations throughout the community and opportunities to add lighting with upcoming roadway projects such as the Annie and Mary Trail improvement project along South Railroad Avenue. Once developed, the lighting inventory can be used to develop a streetlight installation and maintenance plan, which can increase the sense of safety and security and improve the overall well-being of community members.

The Project Team also recommends the Planning Committee review the <u>International Dark Sky Association</u> website for dark sky friendly street lighting options. Some considerations include light fixtures to replace the existing flood lights, residential lighting options to share with residents, and the installation of dark sky friendly residential lighting that offers security benefits.

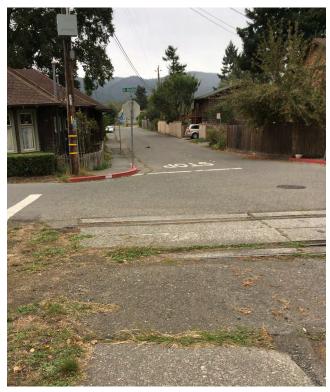
- The assessment area generally lacked curb ramps when sidewalks were present. Specific locations include: Chartin Road/Hackett Road, Chartin Road/Broderick Lane, South Railroad Road/Chartin Road, Blue Lake Boulevard/Greenwood Avenue.
- In areas where sidewalks did not exist, participants noted that traveling using a wheelchair or other
 assistive mobility device may be difficult in spots where the pavement is in poor maintenance or
 abruptly ends at the shoulders.

<u>Left:</u> Missing curb ramps at the intersection of Broderick Lane and South Railroad Boulevard.

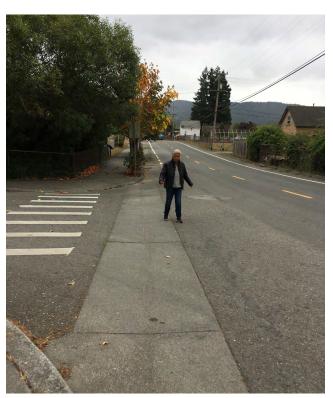
Right: Curb ramp along Chartin Road at South Railroad Boulevard.

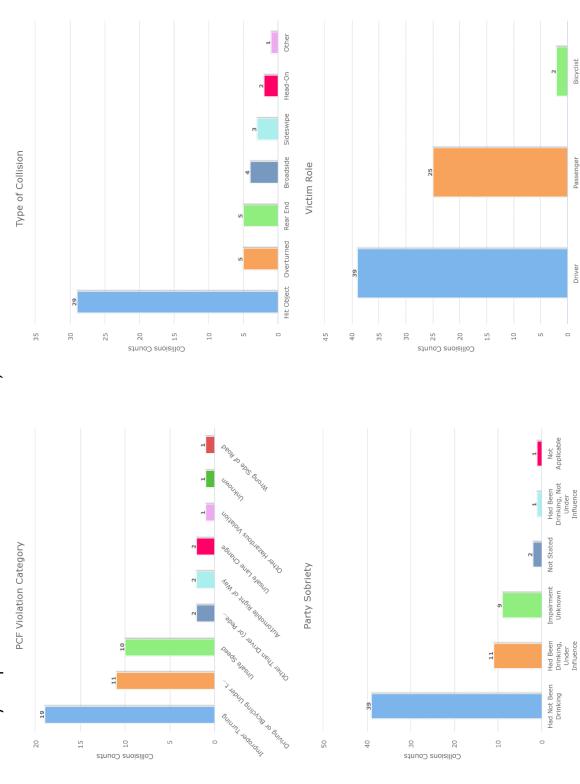
California Tribal Data Viewer

Sample Summary Reports for Jan 2008 to Dec 2017; 2-mile buffer from Blue Lake Rancheria
